A HIDDEN TREASURE OF STAINED GLASS IN SOUTHERN CALIFORNIA BARLOW RESPIRATORY HOSPITAL LIBRARY

ANCIENT ARTS STUDIO PERFORMS MANY CHURCH WINDOW REPAIRS AND RESTORATIONS

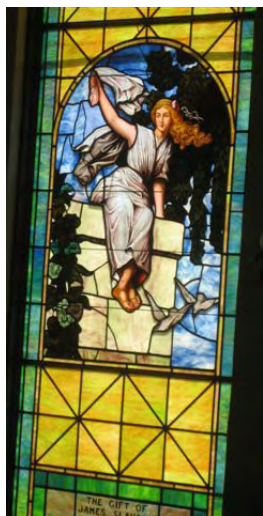
Barlow Respiratory Hospital Library
James Slauson Window
Los Angeles, CA, 2007

The Slauson window was structurally sound, but had suffered noticeable impact cracks to the face and one arm and BB holes in a foot and a piece of the wall. This is a work of intrinsic artistic value and the best course was to carefully clean the affected areas and then to use a technique called cold painting. The visibility of the damaged areas was greatly minimized and the original art work was preserved.
